SPECIAL REPORT ON ANADROMOUS STREAM SURVEYS OF CLEVELAND
PENINSULA, INCLUDING EMERALD BAY, VIXEN INLET, UNION BAY,
CLARENCE STRAIT, BOND BAY, SPACIOUS BAY, AND PORTIONS OF
PORT STEWART AND HELM BAY

Subdistricts 101-90 and 101-80

Volume II

March 1985

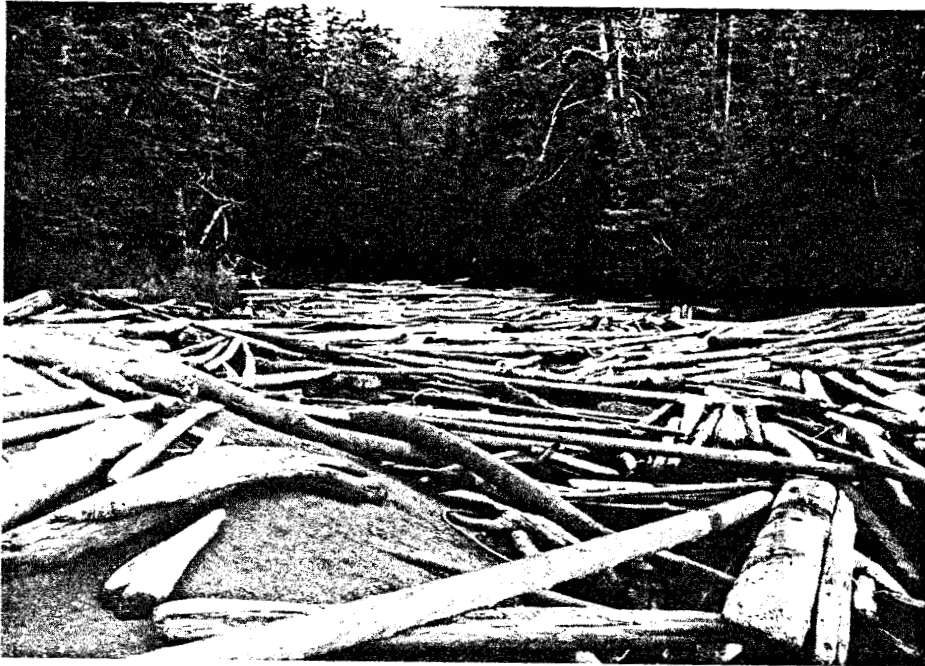
The entire ITZ was covered by an extraordinary driftwood log jam. The debris loading was 100% and it was difficult to determine the bottom type or ASA. Many rearing coho were observed utilizing the driftwood as cover. Two Peterson disc tags were recovered.

1. Log jam in the ITZ.

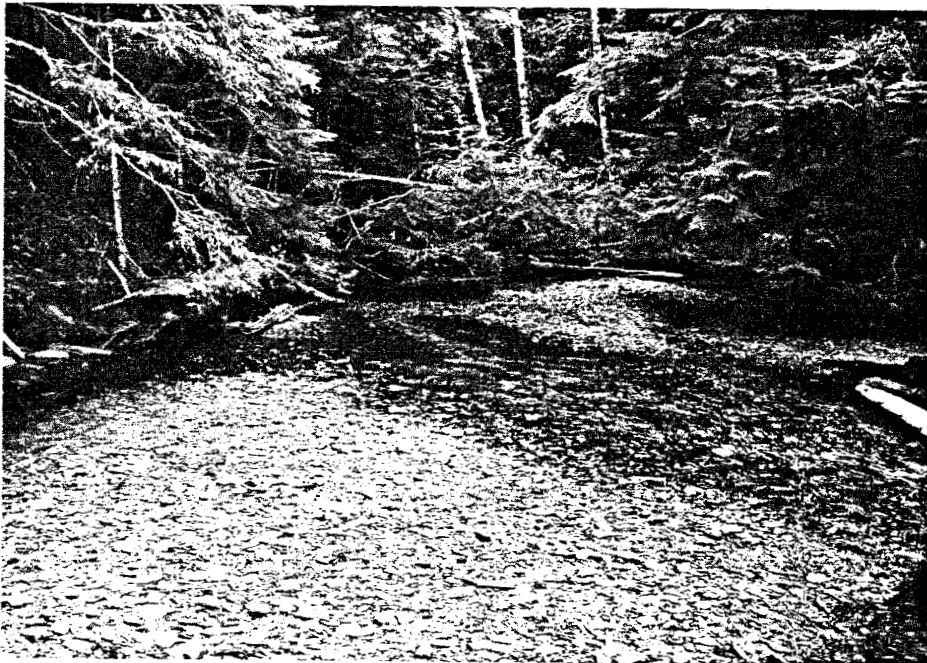
2. Section 1: Excellent riffle area.

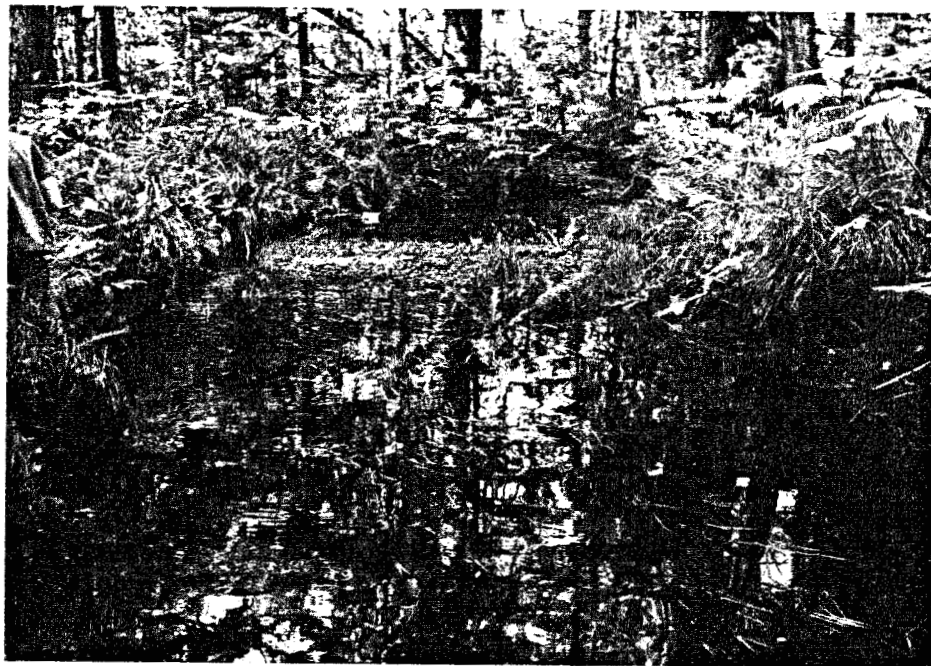
4. Section 6: Grass growing in midstream.

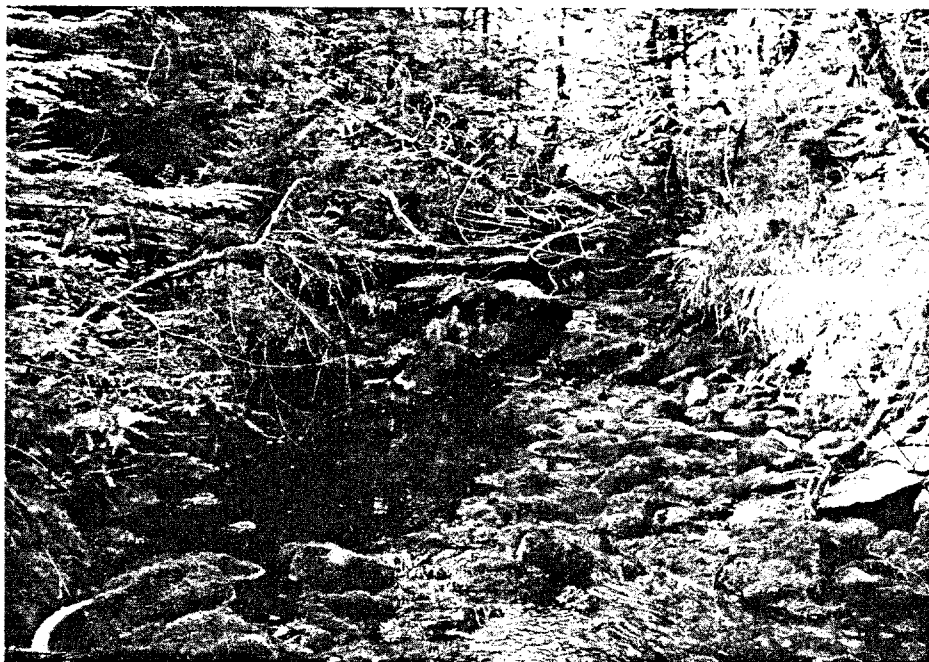
5. Section 9: End of survey.

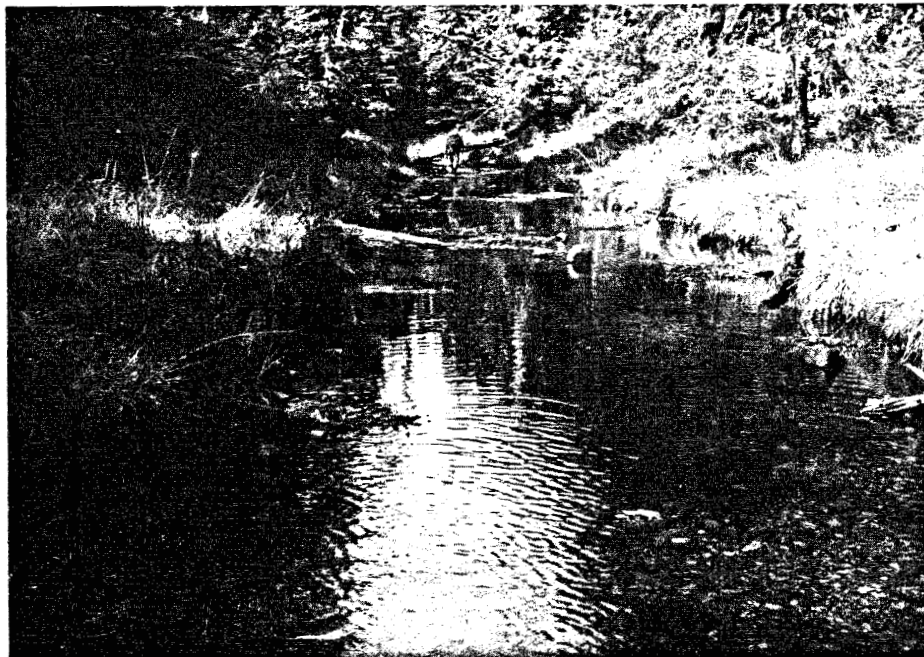
2. Section 1: Midway through the Section.

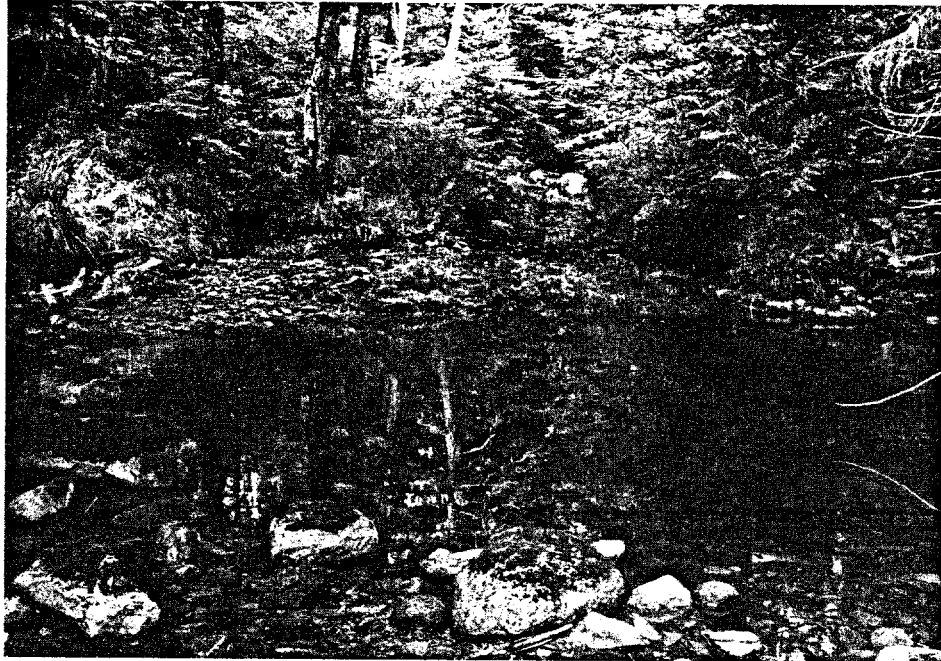
3. Section 2: Small pool at the end of the Section were several pink salmon were seen.

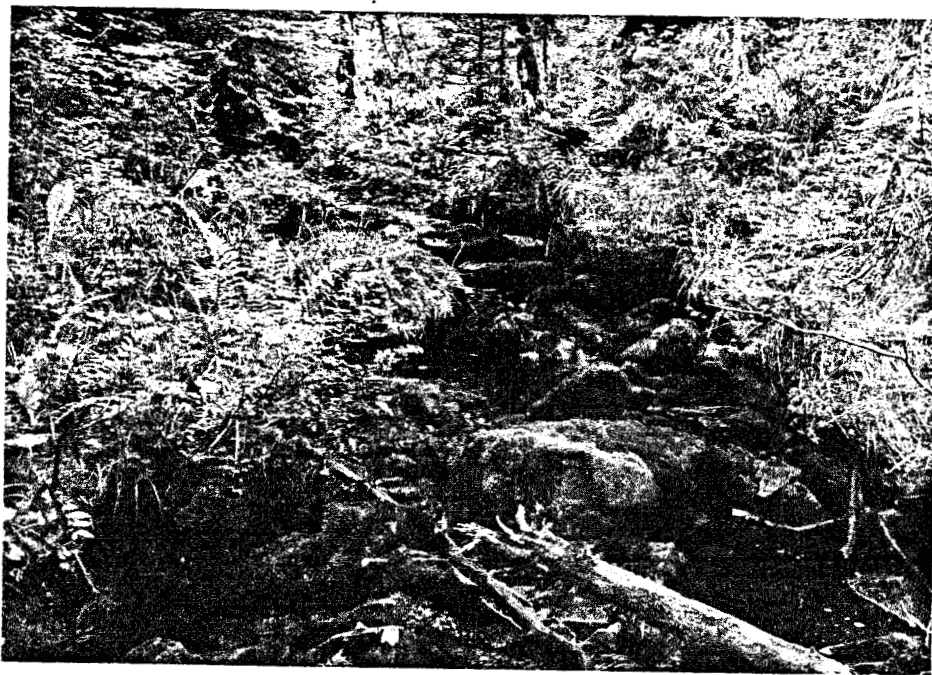
5. Section 6: End of survey on the right fork.

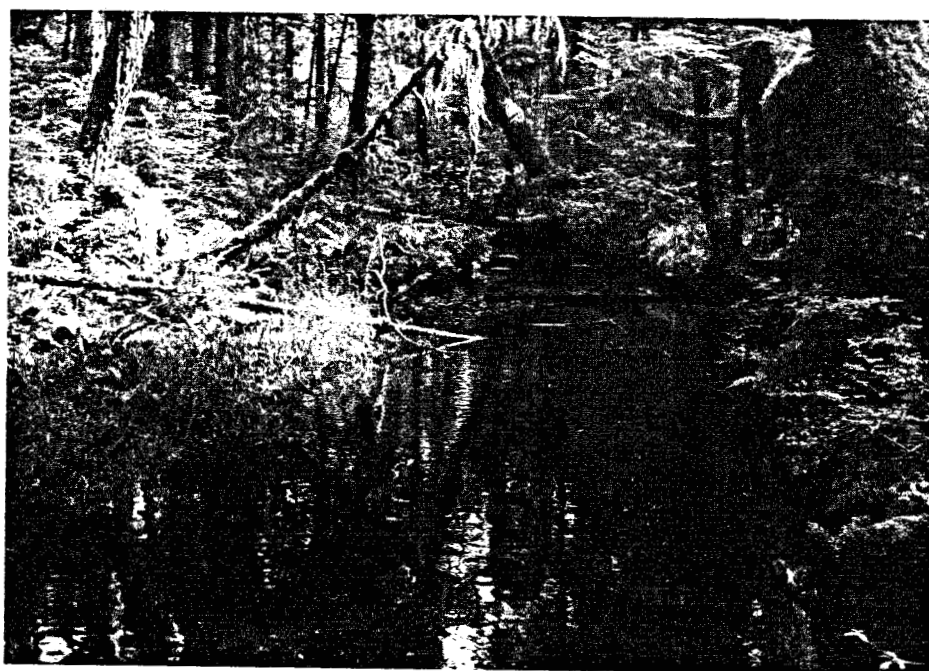
6. 150 m. up the left fork: Excellent rearing habitat and possible ASA at higher flows.

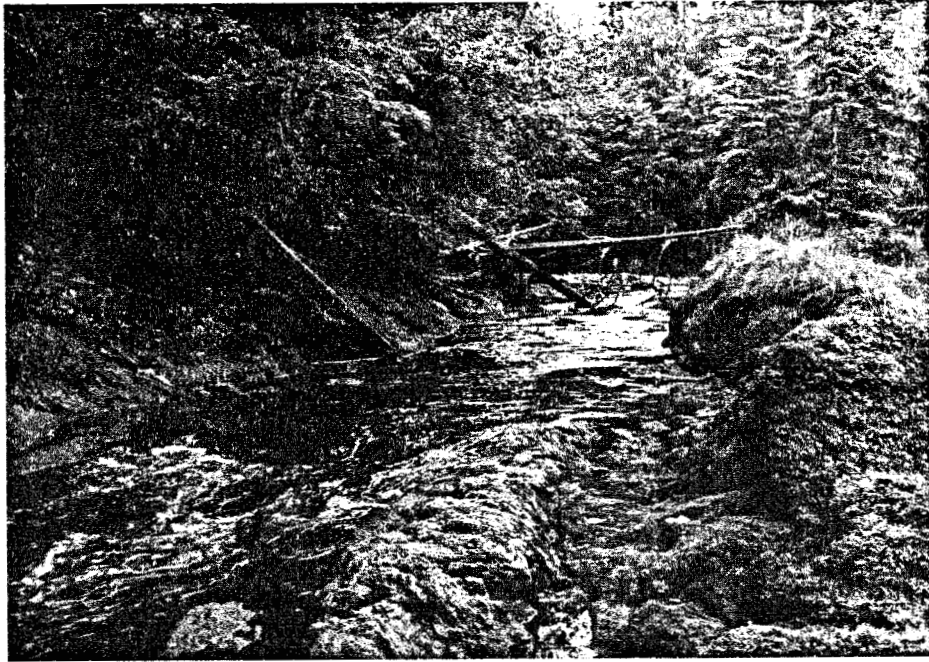
1. Bedrock boulder substrate of middle ITZ.

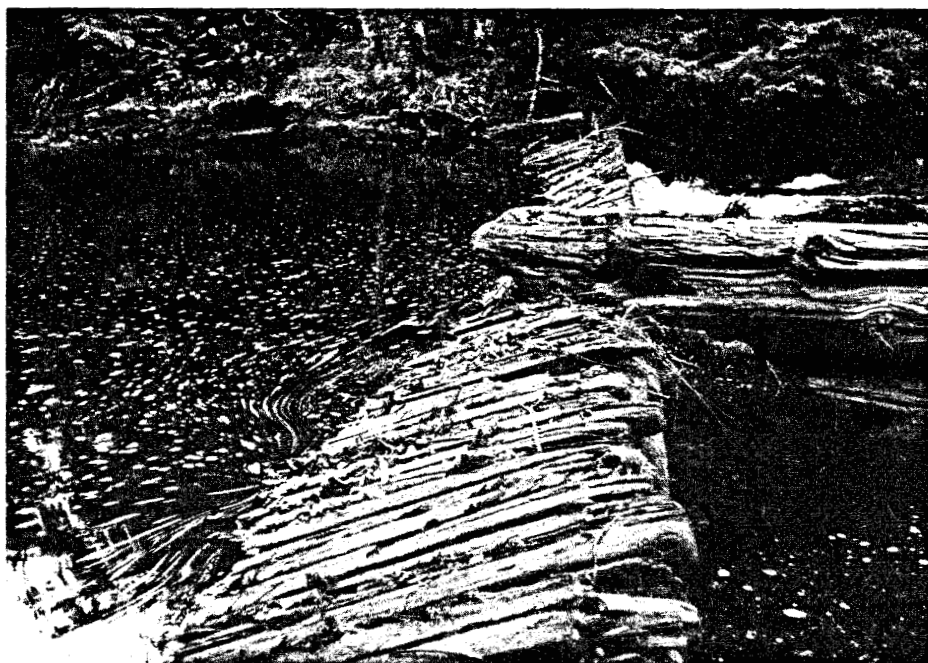
3. Side view of man made dam at the end of Section 1.

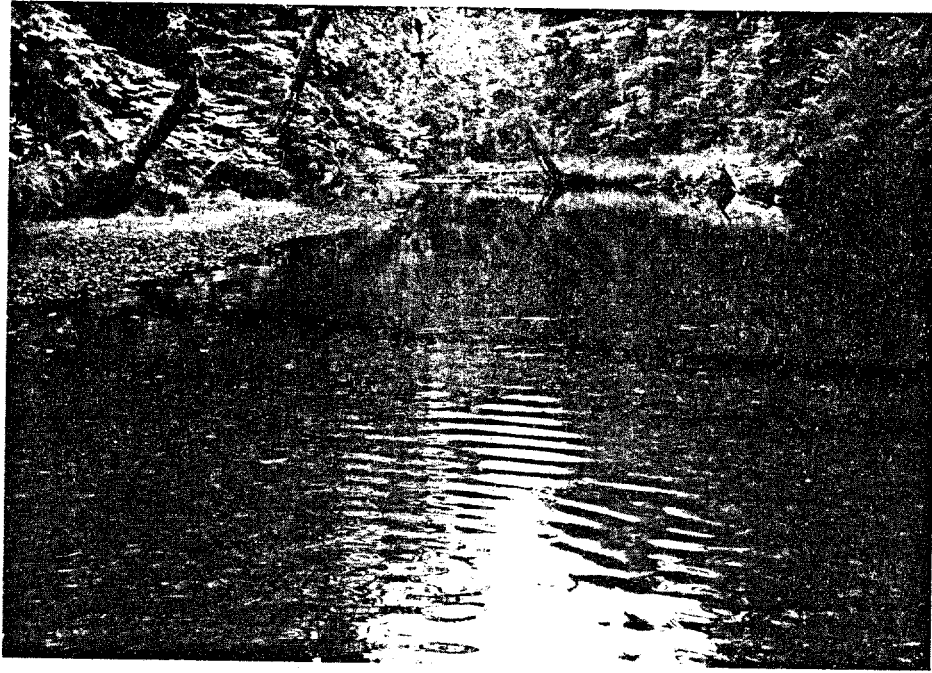
5. Section 6: Rearing habitat and substrate that provides good ASA in Reach 2.

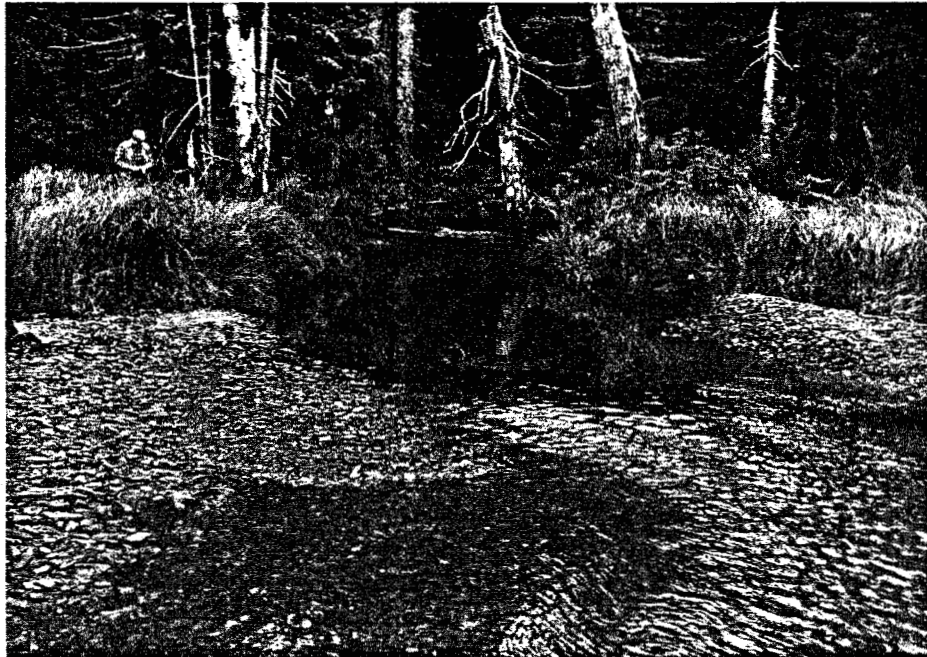
1. Section 1 Good ASA for the first 30 m.
Rearing area is excellent.

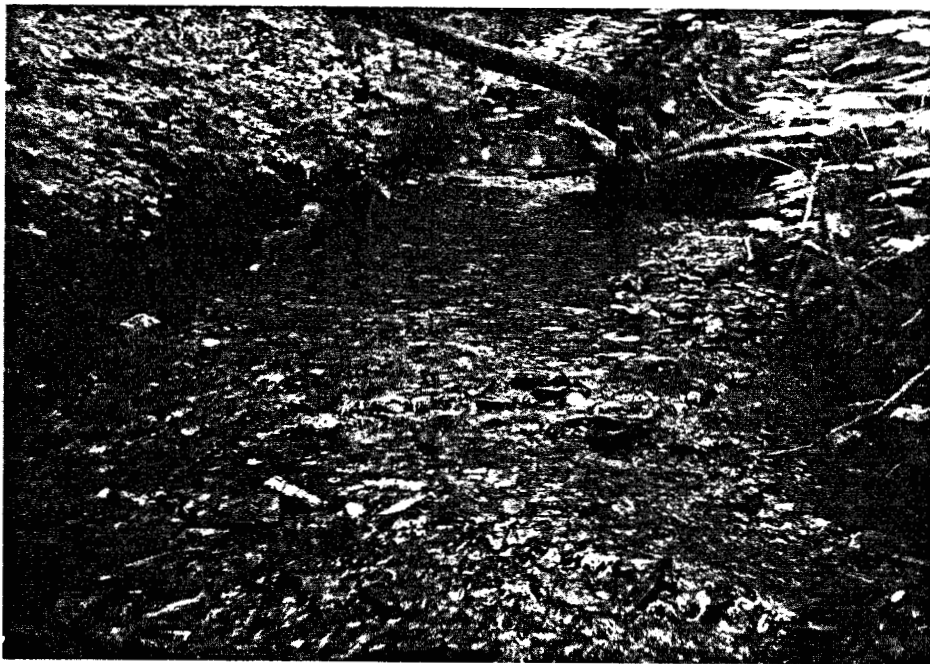
2. Section 3 Good shallow riffle area.

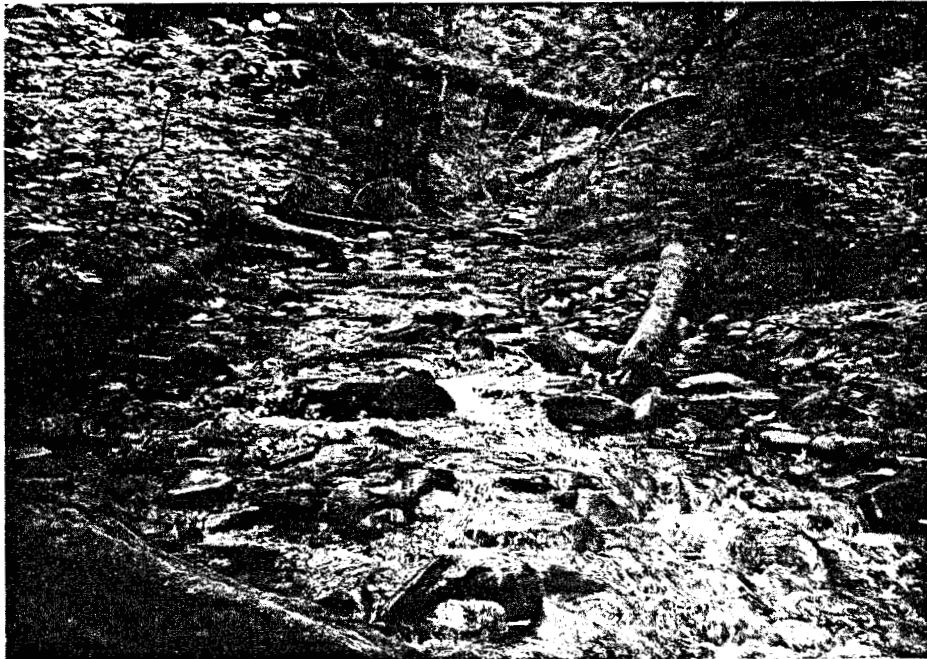
3. Section 7 Substrate is mostly boulder and cobble.

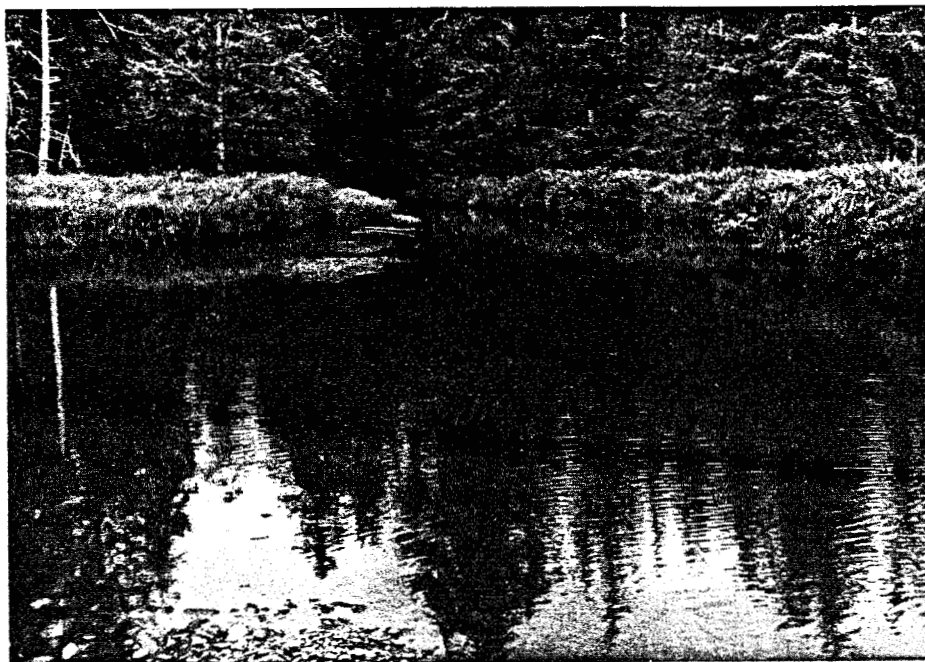
1. Section 1 Sluggish area with no ASA.

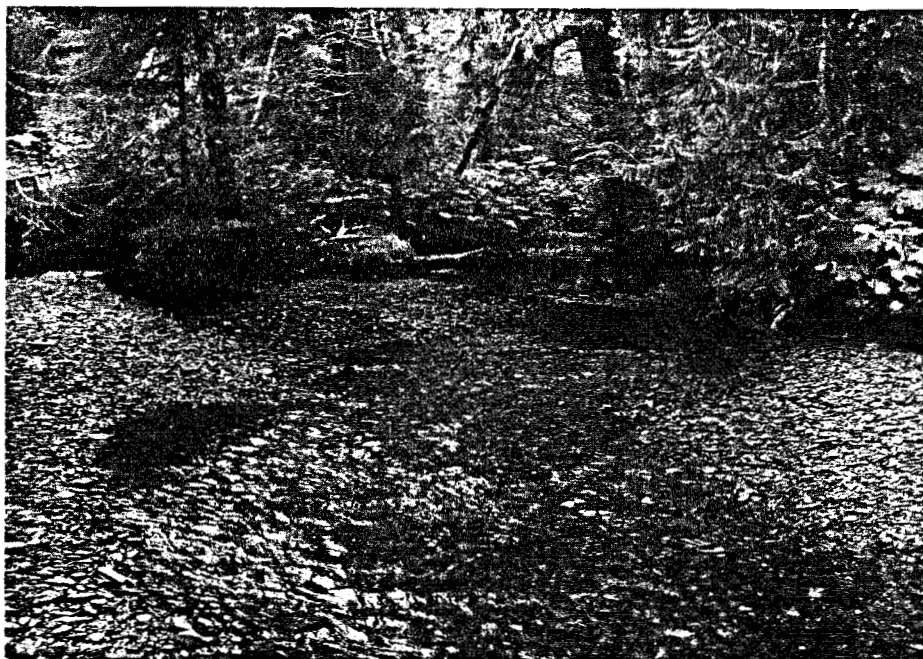
2. Section 4 Good shallow riffle area.

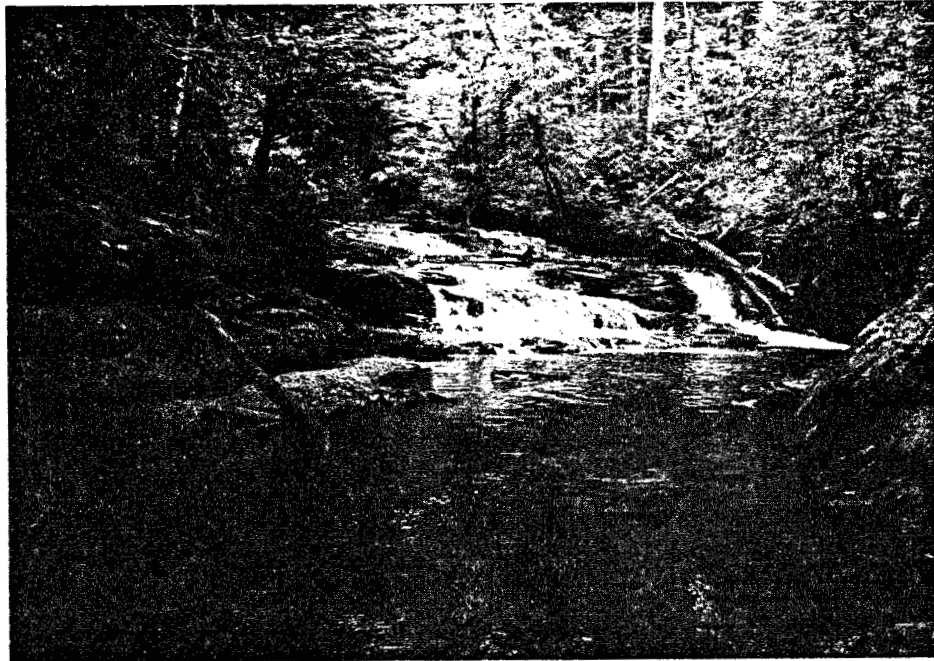
3. Section 7 A 2.5 m. stairstep falls midway through the Section.

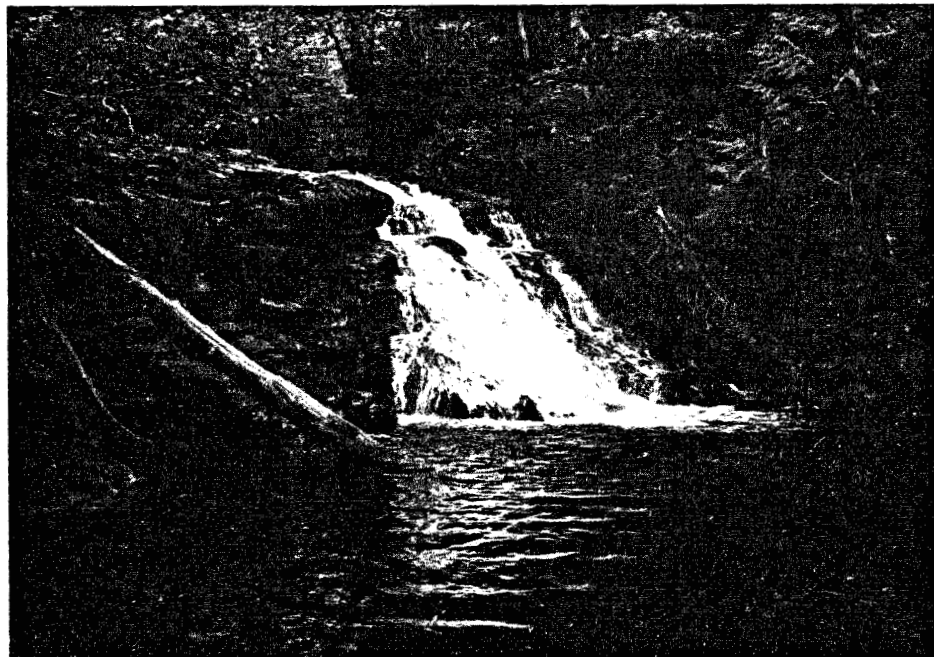
4. Section 8 4 m. barrier falls with a gradient of 55%.

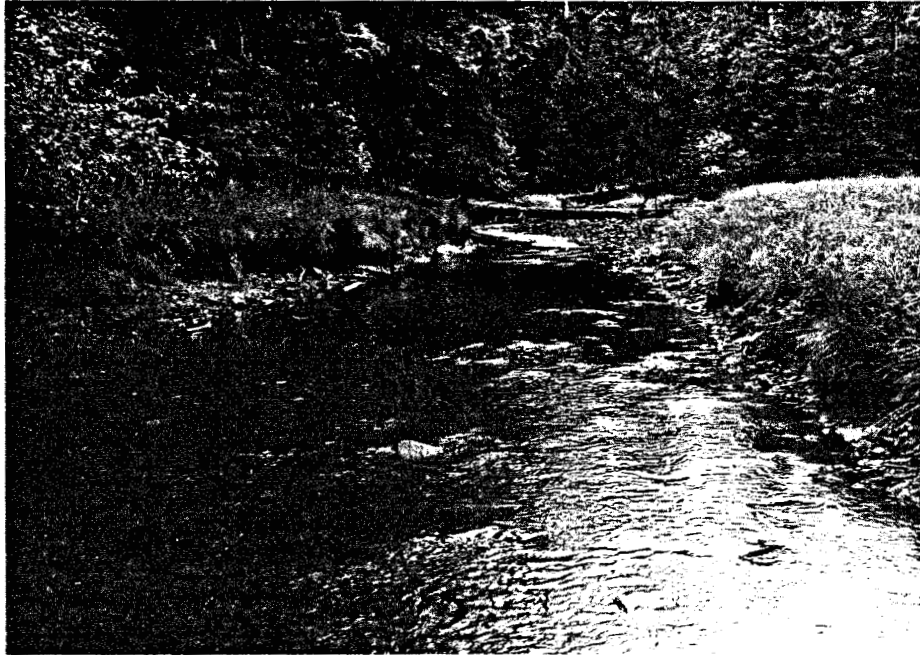
1. ITZ: The substrate is rather compact and filamentous algae is present.

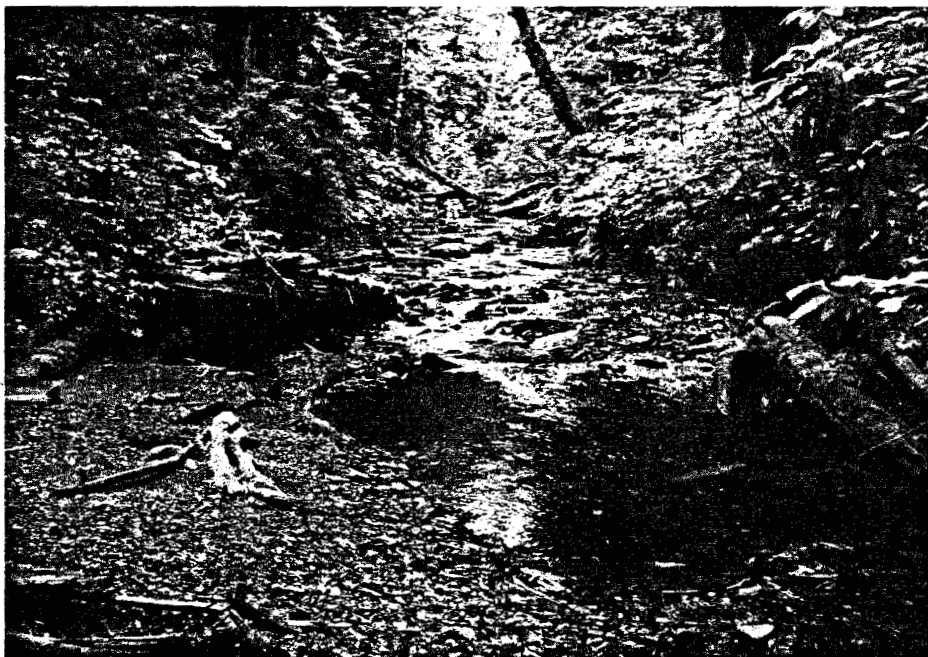
2. Typical habitat in Section 2. The ASA is poor quality due to the compact, flat substrate.

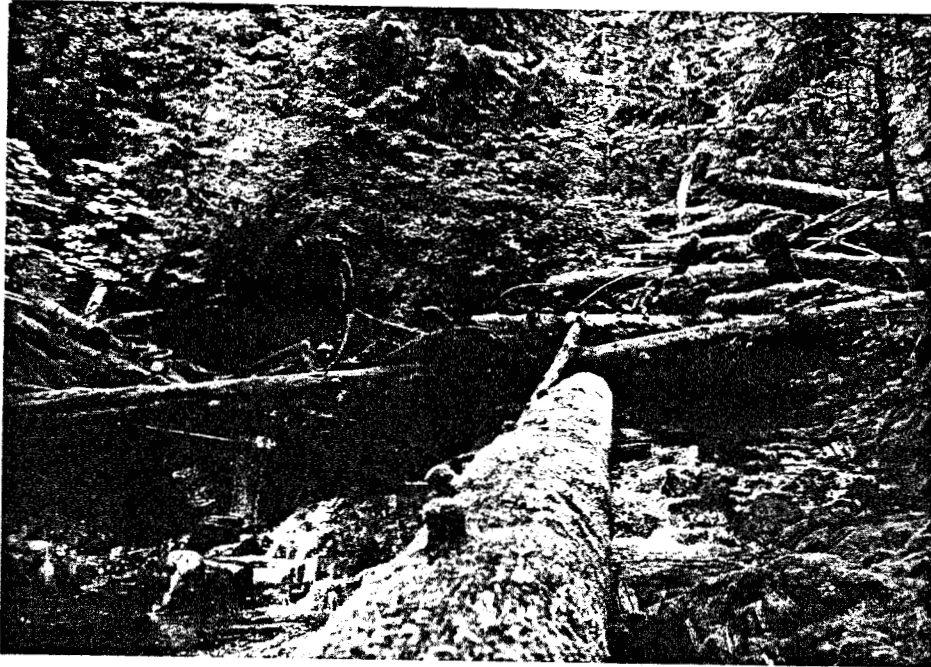
3. A potential log jam barrier in Section 4.

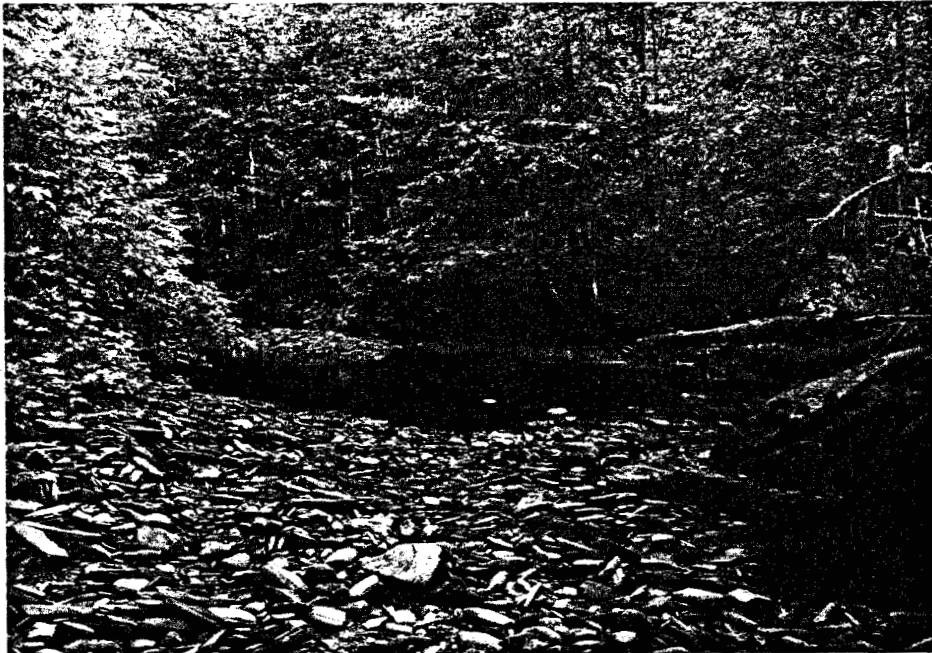
2. Typical flat substrate in Section 3.

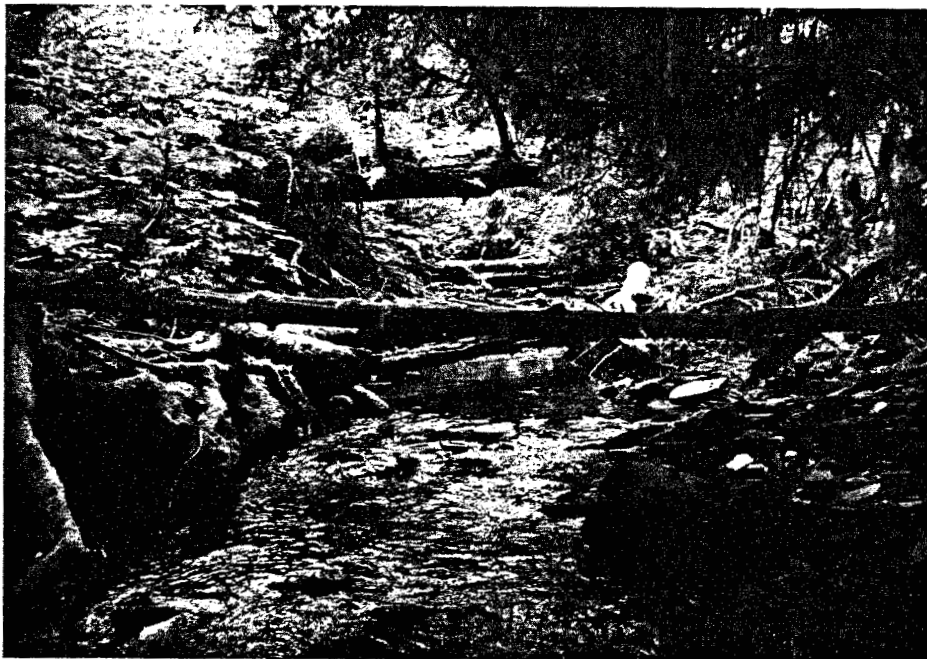
4. Section 1: Area B ASA was poor quality due to
the large flat substrate.

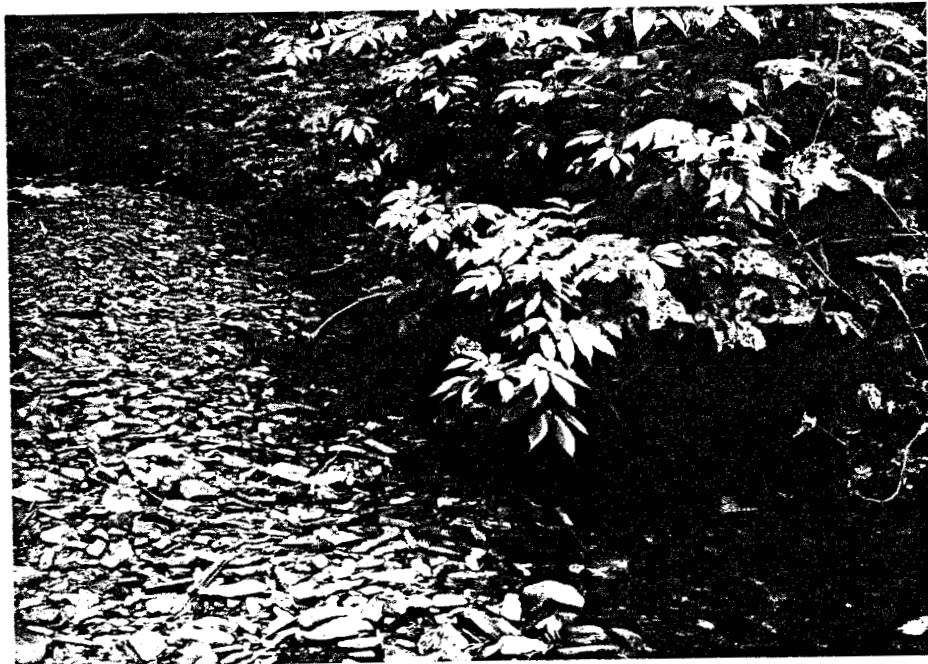
6. Area C Section 1: Rearing coho were utilizing the heavy overhanging riparian vegetation in Sections 1 and 2.

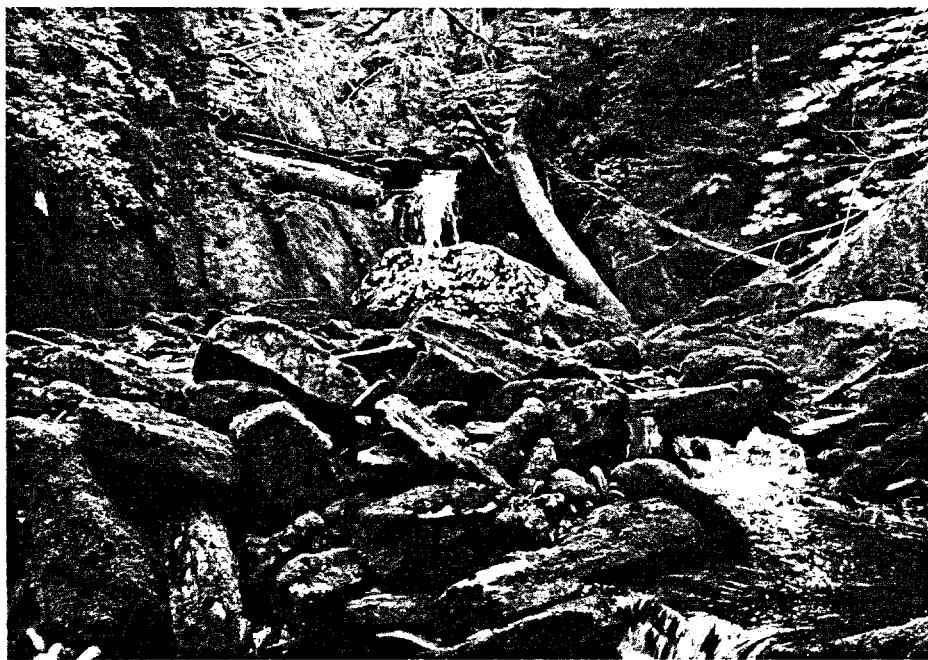
2. 175 m. upstream looking at 3.5 m falls.

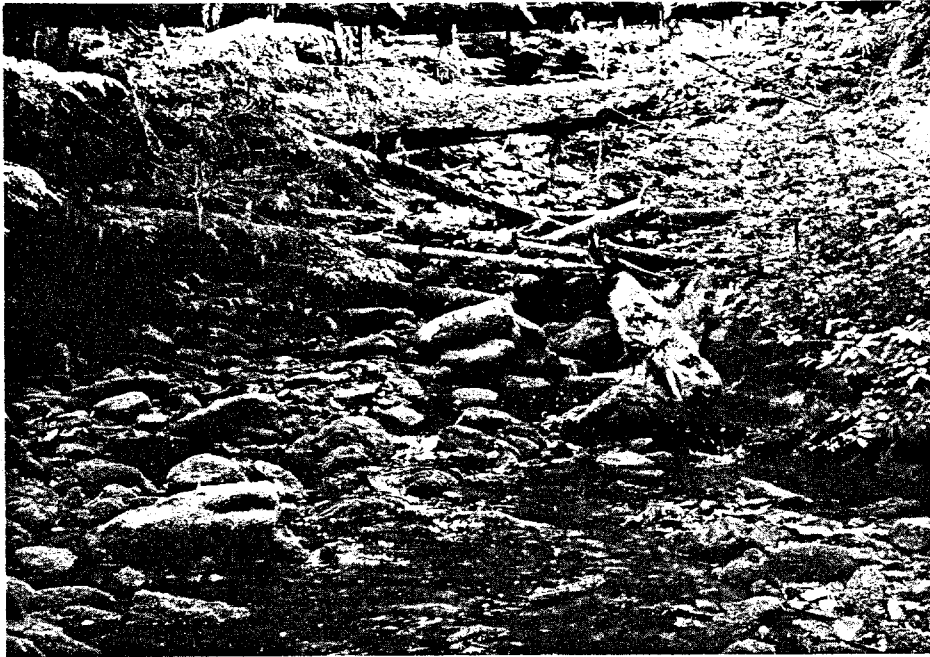
3. Section #7 Debris jam with small falls.

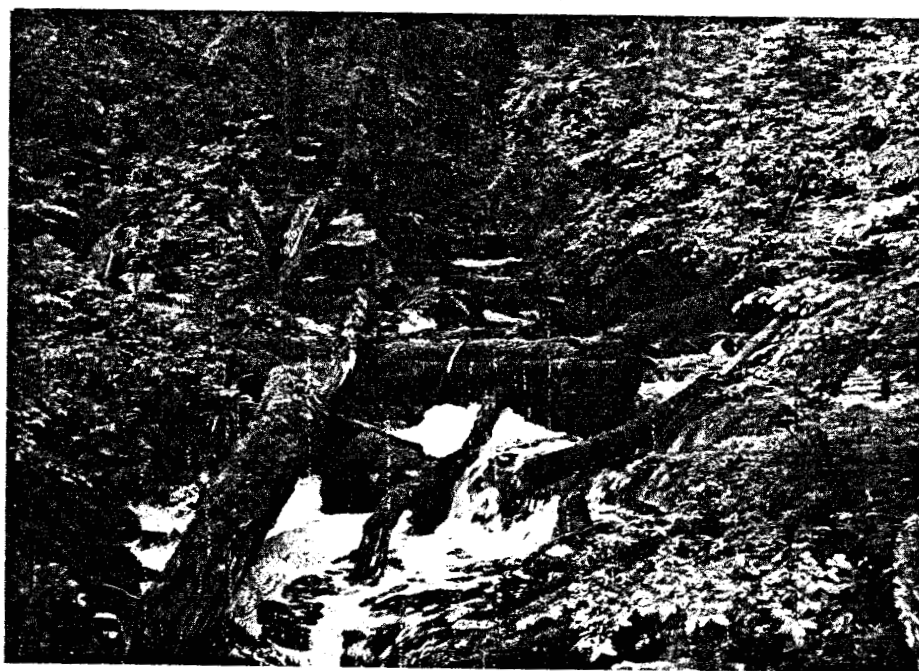
2. Section 2: Typical habitat included a steep gradient and large substrate.

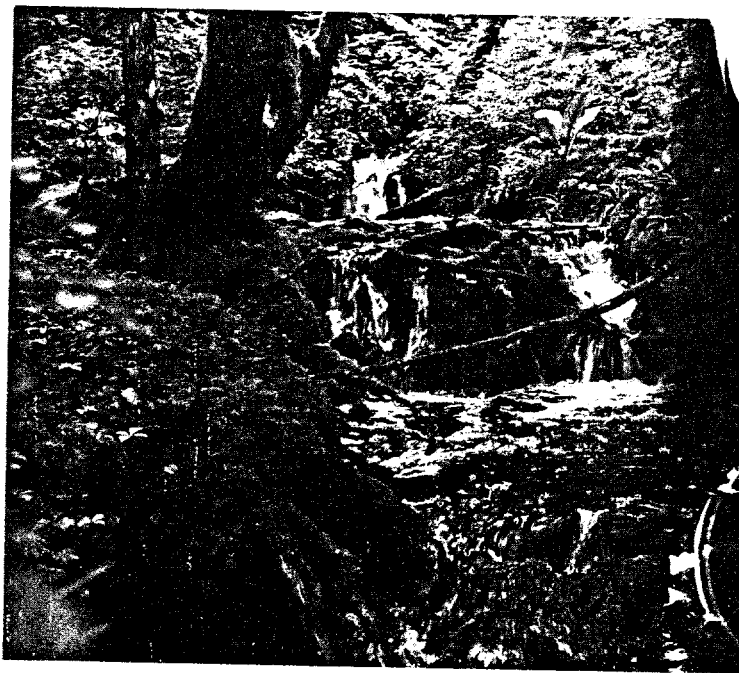
4. Section 9: Typical habitat at the end of the survey.

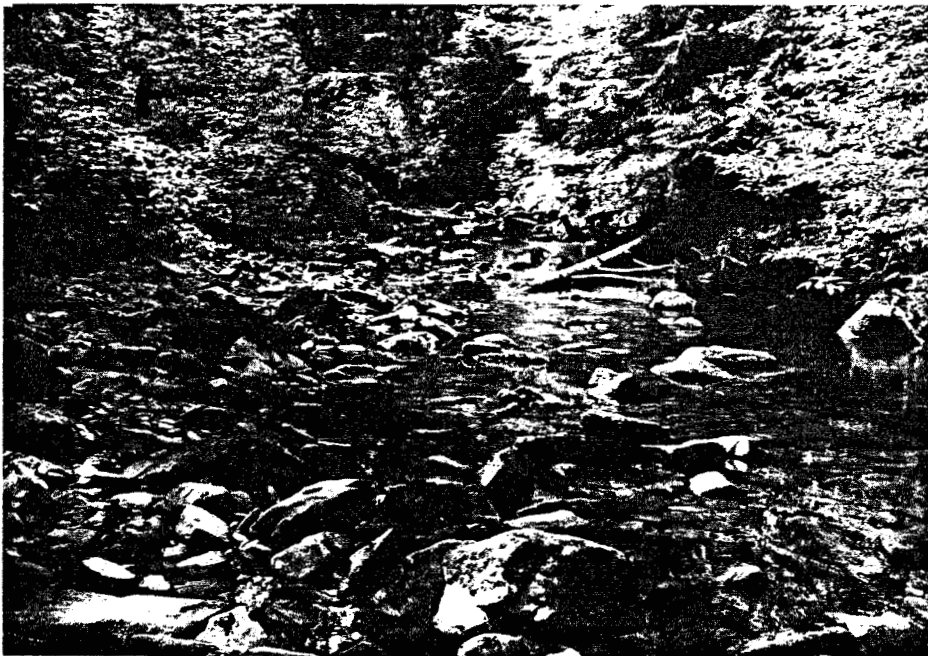
4. Section #10 Above where braided channels join.

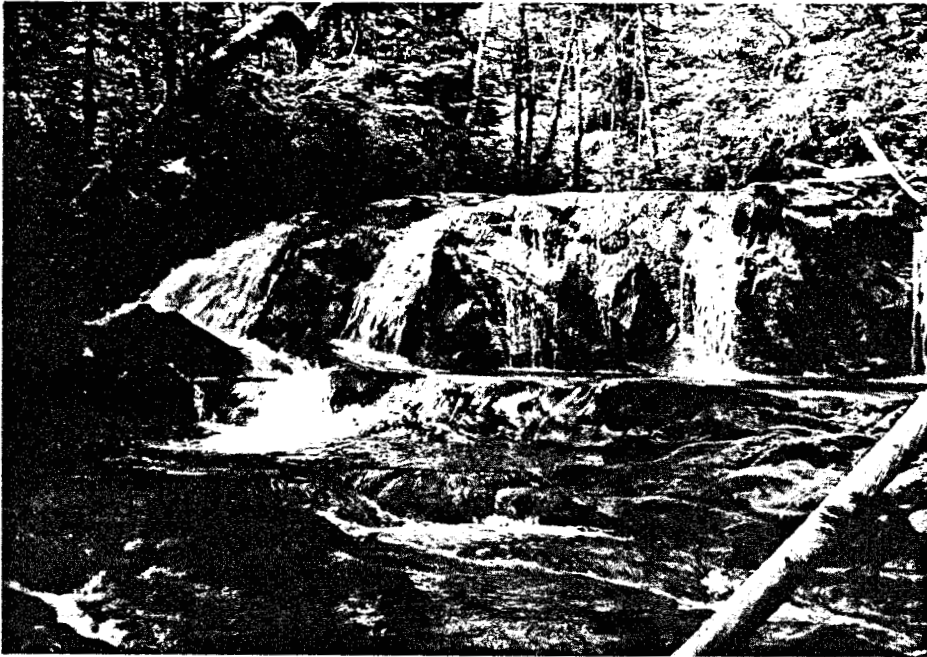
7. Barrier Falls 100 m. past the end of Section #14.

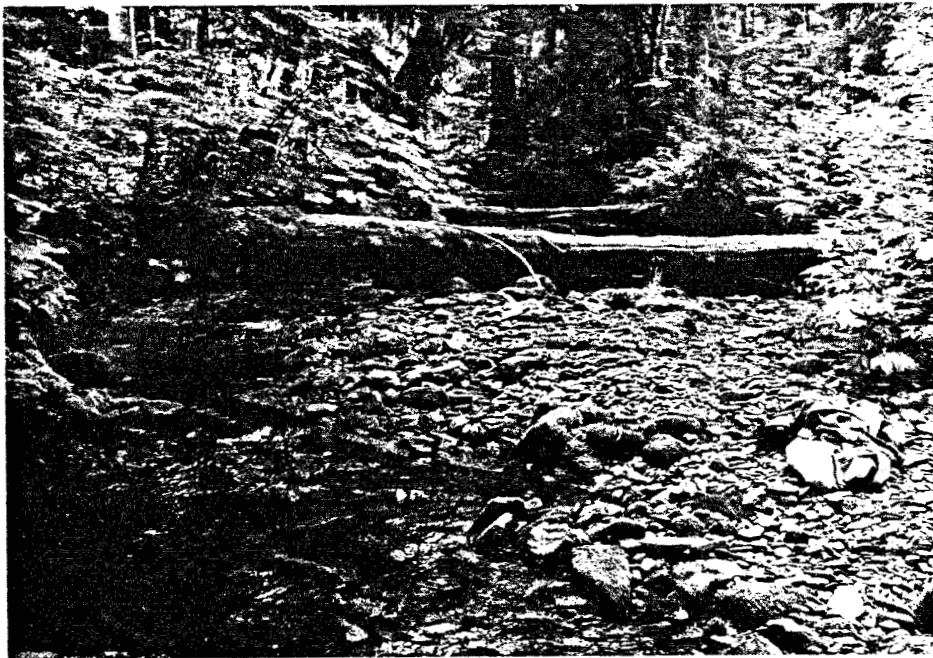
8. Typical habitat above the barriers.

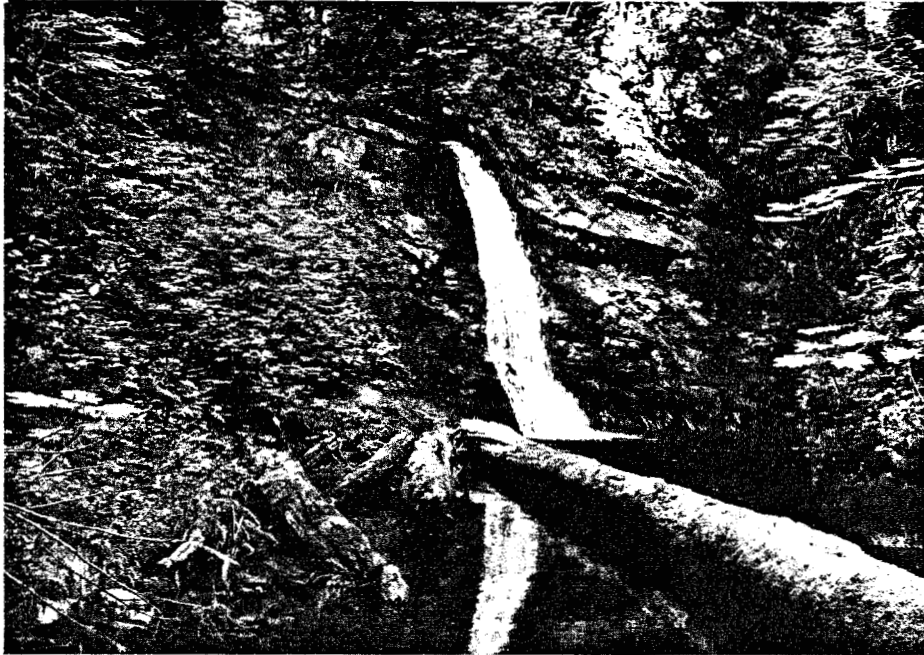
5. Barrier falls 70 m. into Section #14.

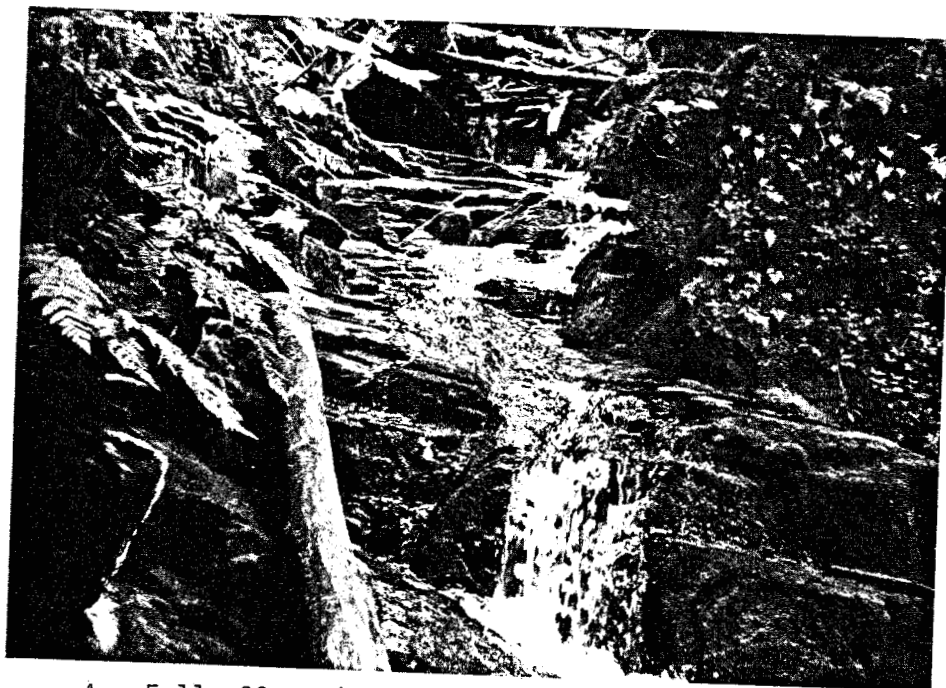
4. Falls 90 m. into Section #4.

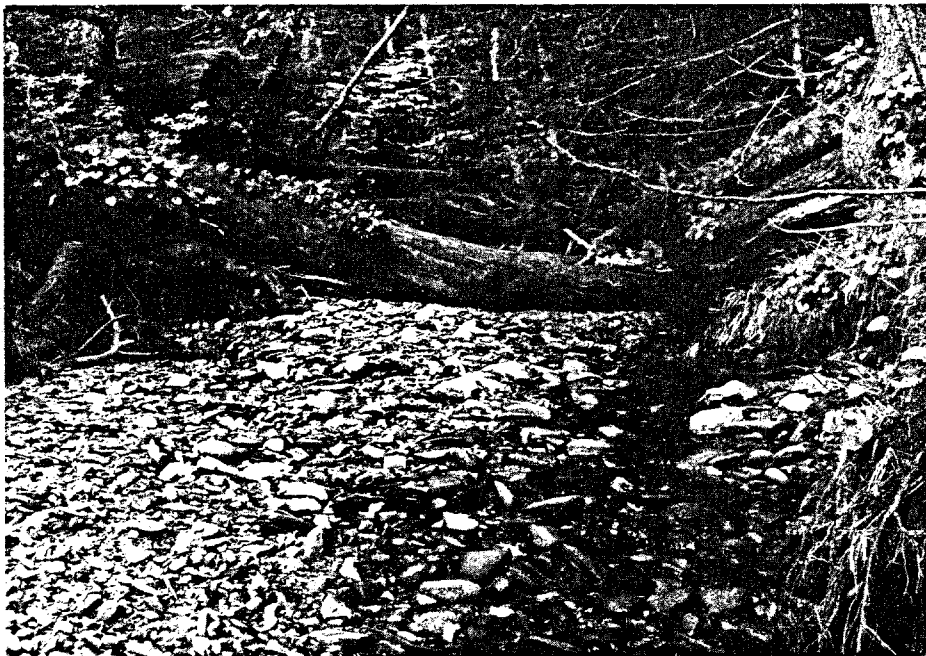
2. Beginning of Section #1.

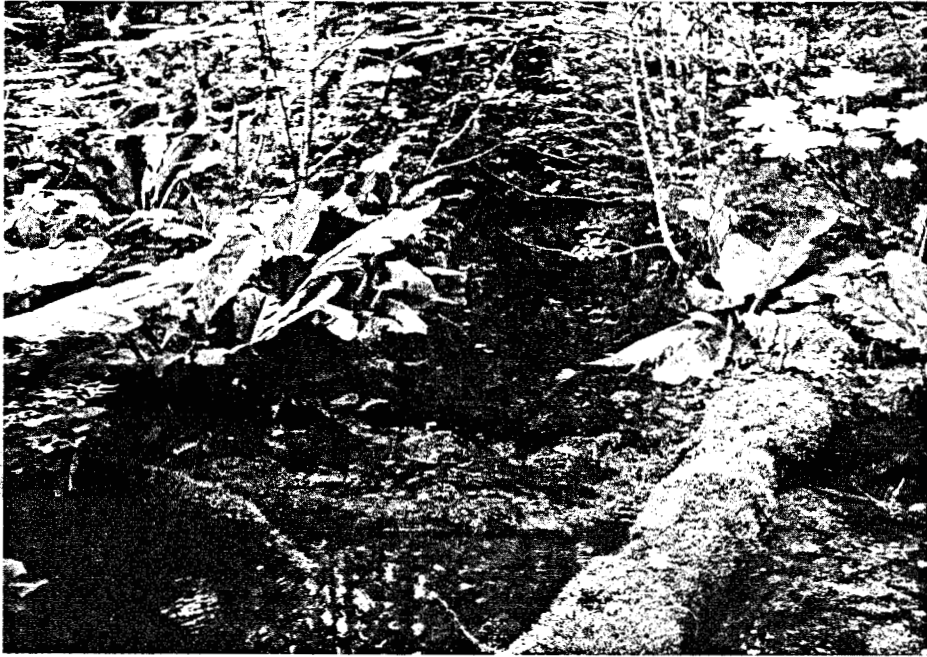
3. Section #3.

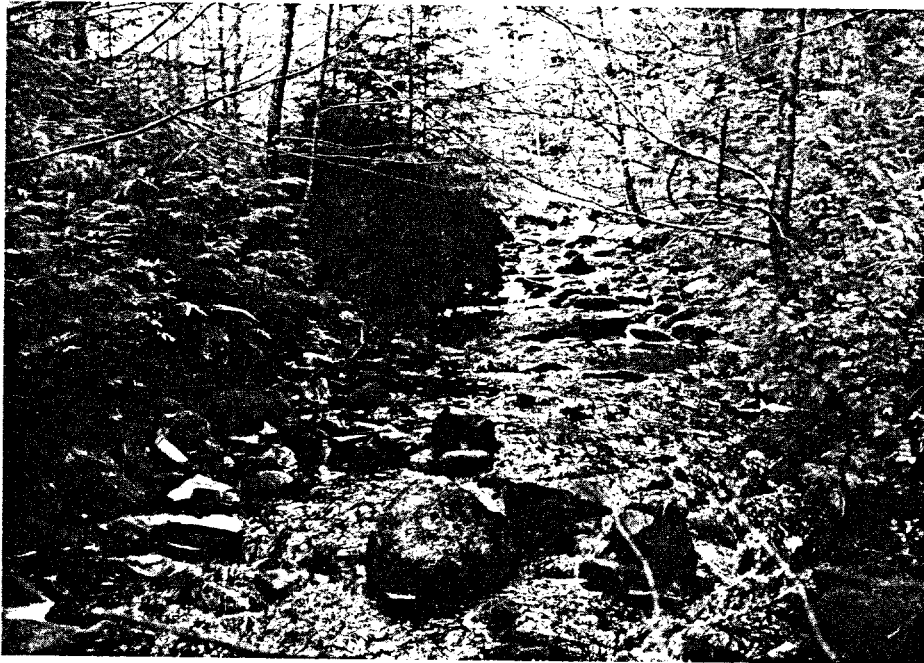
2. Typical habitat: Stream was characterized by a large substrate and lack of debris loading.

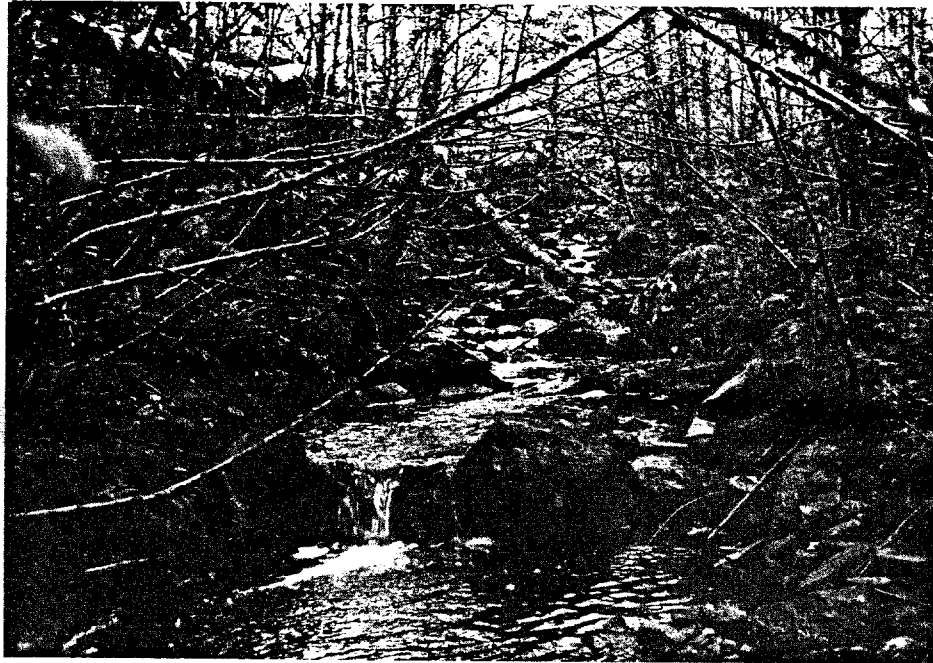
3. Habitat above the end of the survey at Section 7
